KAIKOURA EARTHQUAKE UPDATE

WEEKLY BULLETIN – no. 5

24 February 2017

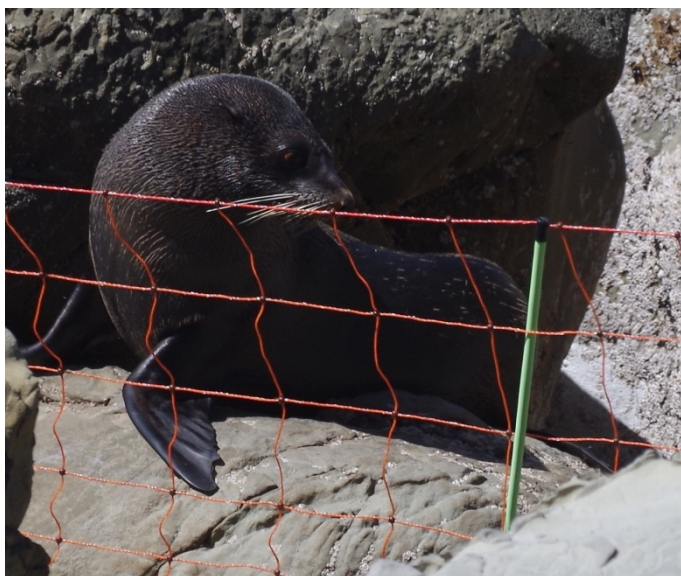
The first phase of this work is two-week trial, which is now underway at Site 7, a 20,000 cubic metre slip 300m north of Ohau Point. The trial is using seal-proof fencing (pictured above) and on-site seal herding to keep seals and their pups away from the immediate base of the slip site, clear of falling rocks and debris while helicopter sluicing and slip clearance work is carried out. The fencing is working well.

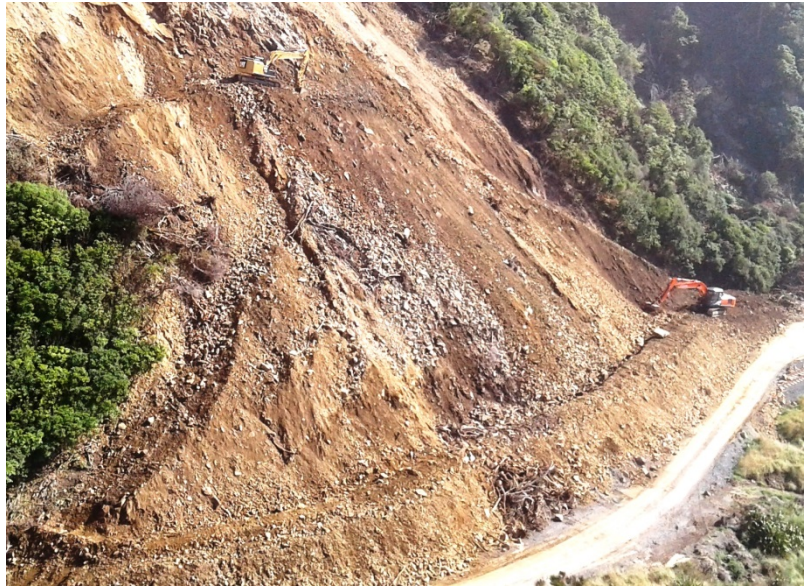
- This week our crews have installed rockfall safety bunds along the bottom of the slips at Sites 1A (pictured right), Site 1B and Irongate (Site 2), about 1km north of Blue Duck Road. These bunds help protect our construction crews from falling rocks, enabling work to carry on on the slip face while other crews travel past the site to access slips further to the north.

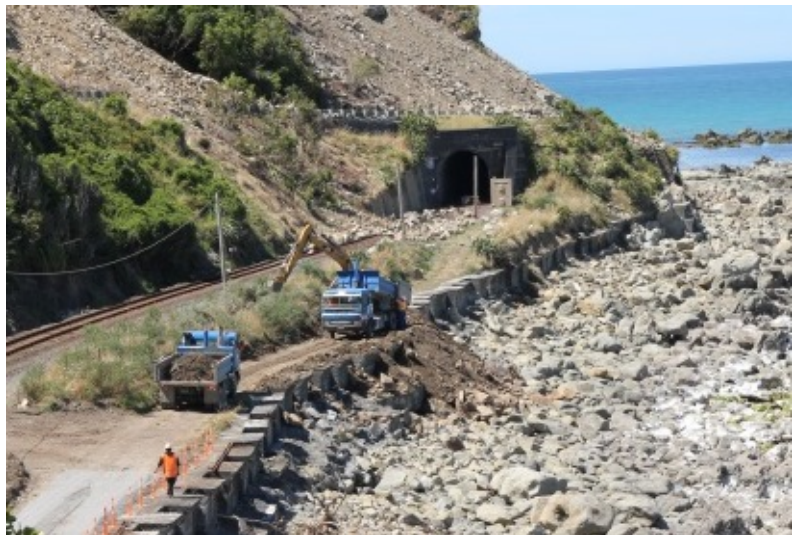
- Four minor slips near Irongate have been cleared this week, the material from these being used to build the construction access track (pictured below, right) around Site 2. This track is expected to be completed by the end of next week.

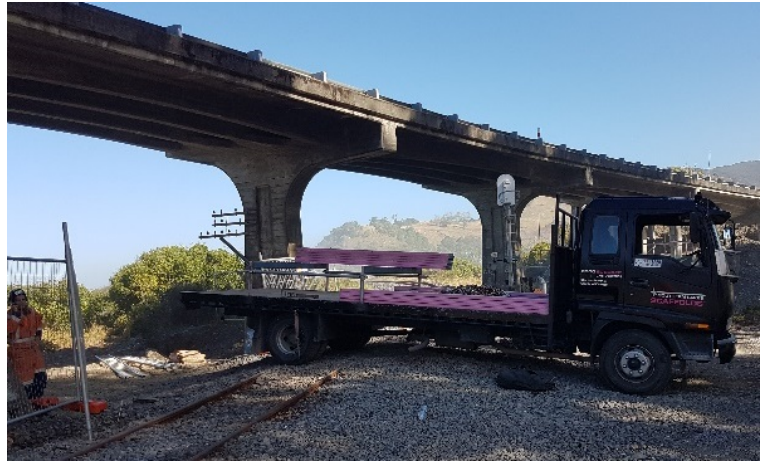
Strengthening of the Oaro overbridge (right) is progressing well. Debris from under the bridge have now been removed, exposing the concrete columns and bridge foundation. Crews have already moved on site to begin removing the minor crack damage. Once completed, the bridge foundations, beams and abutments will be strengthened with structural steel bracing. This will enable the bridge to carry heavy freight vehicles. The work is scheduled to take several months and traffic will continue to be detoured around the bridge until the work is completed.

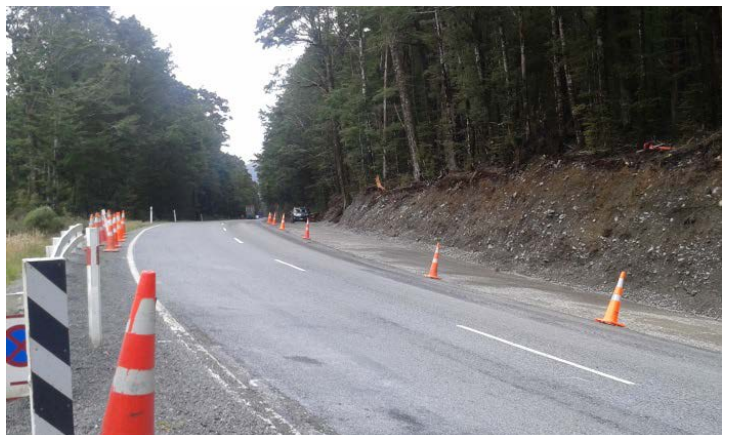
- Protection works are being installed along SH7 where erosion issues have been identified
- SH7 is to be realigned at Silvia Flats (previous page), near Lewis Pass, to protect the road from erosion and slumping. This work will get underway within the next few weeks.
- We're also identifying areas to install slow vehicle bays and improve traffic flow

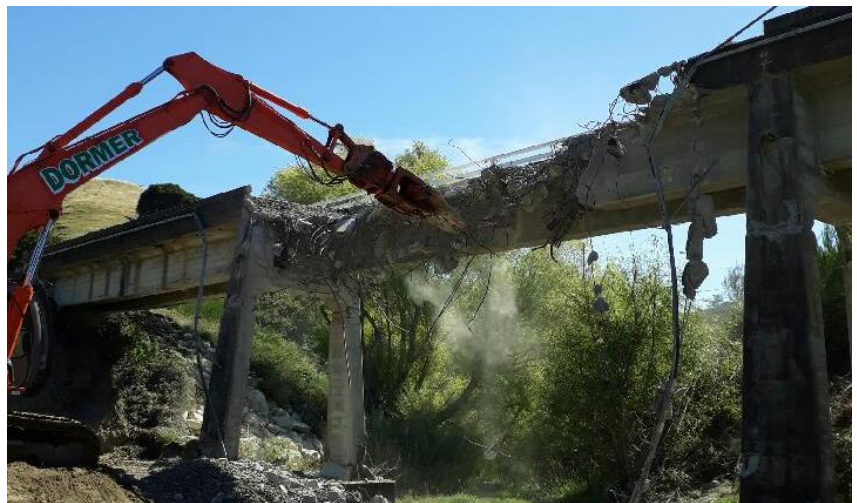
- Demolition of the rail bridge at Ferniehurst (Bridge 90), south of the Hundalee, is well underway (right). This is a major project in the programme to restore the Main North Line between Picton and Christchurch. The bridge will be demolished and temporary bridging spans installed across this section of the line to get it re-opened as quickly as possible. More than 1 million tonnes of freight is moved on the Main North Line each year.

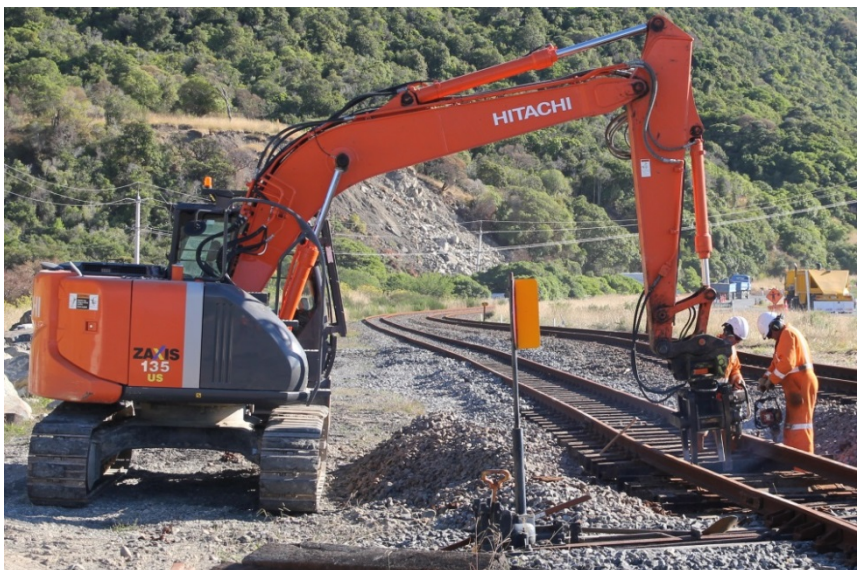
- Near Hawkswood, just north of Parnassus, work got underway this week repairing more than 200m of track, including culverts and retaining walls, which have slumped. This is a big job that is critical to the overall repair programme for the rail network. This will enable the line to be used for the movement of equipment further north. Several crews are working at this site.
- Ballast trains are bringing stones along the rail line to the sites where the sleepers have slumped. The ballast is laid on the ground and the rails on top. The earthquake caused the ballast to slump at many locations.
- With access tracks being built around the slips to the north of Kaikoura, KiwiRail teams can now begin detailed assessments of the tracks in this area to help finalise the design and construction timetable. Like the highway, the rail tracks have been badly damaged.

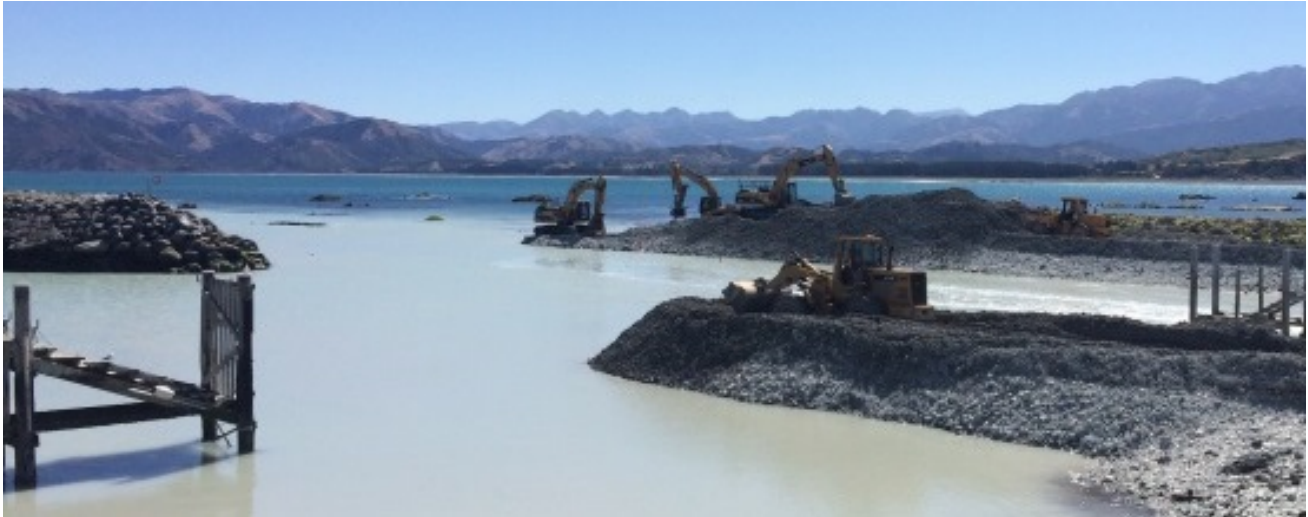
- More than 10,000 cubic metres of material has now been dredged from the main marina channel. This is being used to construct a cofferdam across the marina basin: a watertight enclosure pumped dry area that will enable construction work can get underway to deepen the marina basin below the waterline within the harbour.
- We're investigating barge options to excavate the outer channel of the harbour - 200m beyond the harbour wall. This area is too deep to excavate from the land.
